MARINE SURVEY REPORT

OF THE MOTOR VESSEL: "WCG00266F606"

2006 Brunswick Commercial & Government Div. Boston Whaler 27 Vigilant Center Console Fire/Rescue Boat

2006Boston Whaler 27 Vigilant Fire Boat • HIN: WCC00266F606 • Surveyed Sept 25th, 2018by: American Marine Specialists (a Wright Way, Inc. Co.) • Soddy Daisy Tennessee • 423:451.0128 • Page 1

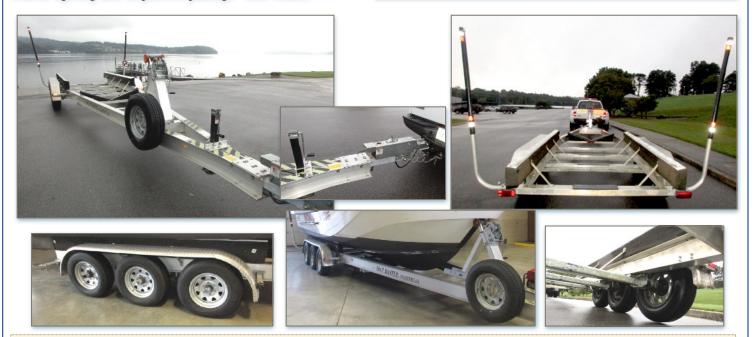
BOAT TRAILER: *(**B.4**) Boat Master Commercial tri-axle aluminum boat trailer equipped with standard; removable tongue w/brake fluid reservoir, emergency brake release fitting, wire harness, and lockable clamp - winch tower w/ manual winch and nylon strap - manual trailer jack - spare tire rack w/spare wheel mounted tire - diamond plate aluminum fenders - standard carpet covered wood bunks - vertical plastic covered steel trailer guides - ST225/750/15 steel belted radial tires w/steel mag wheels and bearing buddies - standard Boat Master lighting and suspension package - disc brakes.

GENERAL OBSERVATIONS: The trailer assembly, including; all accessible hardware and attachments, winch and straps, trailer jack, bunks, wiring, lighting, tires, wheels, and suspension, were generally in above average cosmetic condition for a trailer this age, and all equipment appeared serviceable. *Except where noted in findings*, the brake lights and turn signals, and running lights were operable. *Tire pressure not checked, but inflation appeared low in some tires. Brake fluid and wheel bearing grease not observed. Concerned parties are advised to have all equipment reinspected for condition before attempting to haul or launch the vessel.*

B.4: The aft, left hand trailer brake light and turn signal light did not illuminate - trailer tire inflation was inadequate. *RECOMMENDATIONS; Enable trailer the trailer brake and turn signal lights - be sure ALL its are properly inflated.

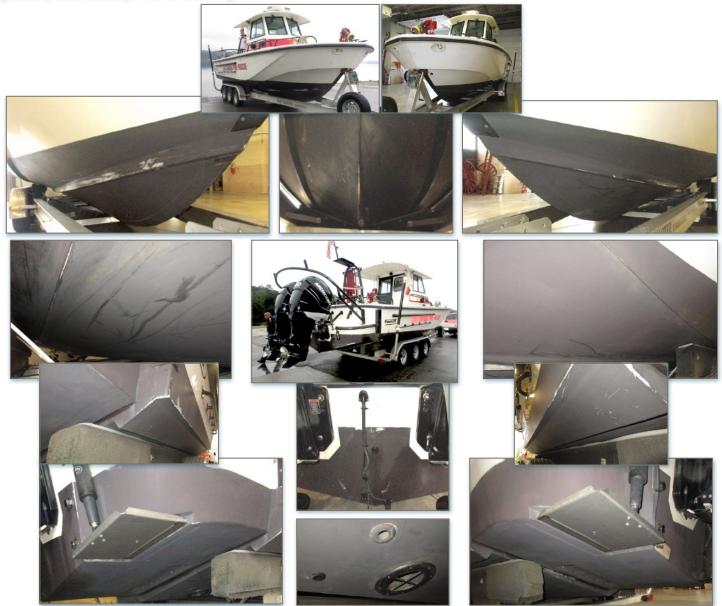
HULL BOTTOM (WETTED SURFACE) - BELOW THE WATER LINE FITTINGS: *(B.5)

Hull wetted surface is factory gel coat finish painted over with a undetermined brand black antifouling paint. The surface was generally clean and dry, with no marine growth.

GENERAL OBSERVATIONS: The wetted surface of the hull was visually inspected with the boat on a low boat trailer, which precluded a complete and thorough inspection of the hull bottom near the keel below the axles. The hull sides and transom were generally in slightly better than average cosmetic condition for a boat this age, with a few (apparently superficial) scrapes and scuffs. The hulls normally wetted surface, (stem, keel, transom, and chines,) appeared sound; with no signs of hard grounding, hard docking, or apparent structural defects. There were NO paint or gel coat blisters observed. Random percussion sounding indicated no readily detectable signs of remarkable delamination or voids. Moisture meter sampling taken with the surveyor's Protimeter SM moisture meter showed no reportable readings; except for a small area on the exterior transom between the motor mounting plates which showed high readings; however, precision soundings and the physical appearancee of the transom were unremarkable.

All thru-hull fittings were well secured and appeared clear - the transom mounted trim tabs, rams, and depth transducer were well secured and in serviceable condition; *the depth transducer was broken off (reportedly on order)* - transom ground plate was well secured, with only mild surface corrosion - outboard motor zincs showed no remarkable wasting.

B.5: The depth transducer was missing; new unit reportedly on order.

*RECOMMENDATIONS; Install depth transducer and verify proper operation of the depth sounder.
