MARINE SURVEY REPORT

OF THE MOTOR VESSEL: "WCG00266F606"

2006 Brunswick Commercial & Government Div. Boston Whaler 27 Vigilant Center Console Fire/Rescue Boat

2006Boston Whaler 27 Vigilant Fire Boat • HIN: WCC00266F606 • Surveyed Sept 25th, 2018by: American Marine Specialists (a Wright Way, Inc. Co.) • Soddy Daisy Tennessee • 423:451.0128 • Page 1

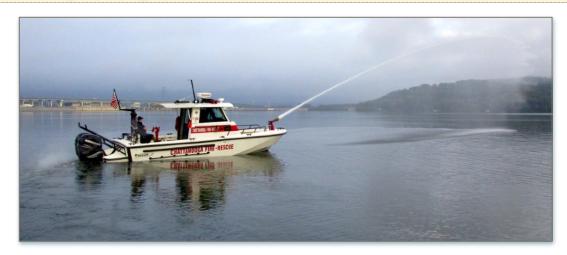
Fire fighting equipment test:

INTRODUCTION: The Westerbeke gasoline fire pump started easily and appeared to function satisfactorily, with good engine exhaust cooling water discharge flow - pump engine instruments appeared to operate normally - the pump had good pressure, and the nozzle remote controller appeared to operate satisfactorily. *Only the bow fire hose/nozzle tested due to time constraints*. The foam system was reported serviceable, *but not tested due to environmental hazard concerns*.
